## FIELD INSPECTION REPORT

<b>Project Name:</b>	Mountain Valley Pipeline	<b>Inspector:</b>	Matthew Grant
<b>Inspection Date:</b>	Wednesday, August 12, 2020	<b>Project Contact:</b>	Brian Clauto
<b>Spread H: Franklin</b>	MP 252.5-253.9, 251.9-252 AR-FR 293.01 ATWS1412, 1055	<b>Weather:</b>	Dry

# FIELD INSPECTION PHOTO LOG

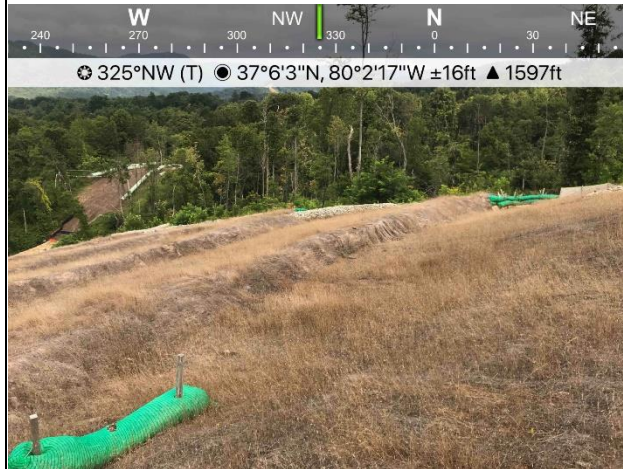
- Figure 1: Permanent style water bars in place near MP 252.9

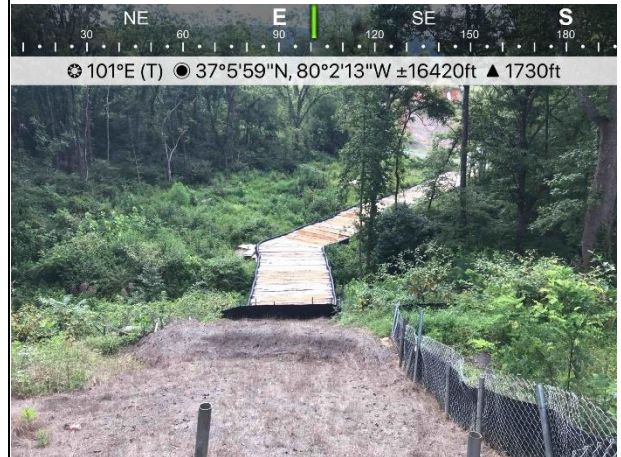
- Figure 2: Above designated crossings S-IJ1, S-IJ3 and W-IJ1 ECD's are in place and functioning.

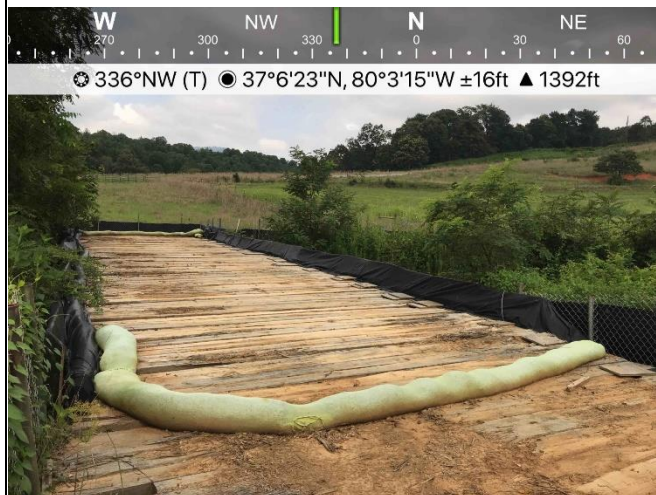
- Figure 3: Designated crossing S-GH7, ECD's are in place.

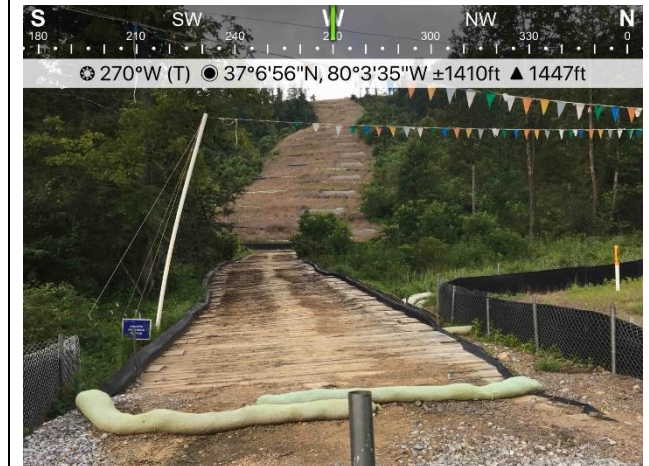
- Figure 4: Designated crossing S-II4 ECD's are in place.
